ROBUST: Renovation of Buildings Using Steel Technologies

**WP 2.4 Physical test on roofs and facades before and after upgrading
to assess their performance**

Individual activity report

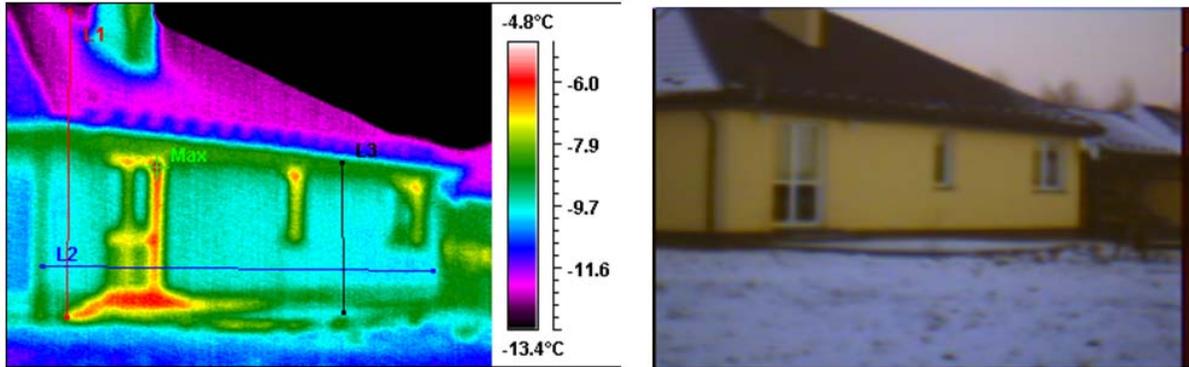
Figure 2. Thermal and natural images of the *ROBERT* building

The range of facade walls and roofs temperature variations (Table 2) as well as the thermogram (fig. 2a) present some low heat resistance areas – in the vicinity of balcony doors (especially near the floor, at the bottom part) and on the window frames.

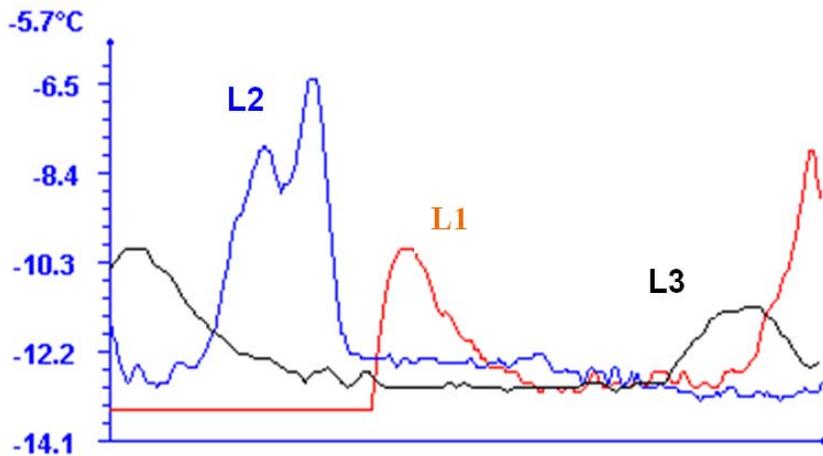
Figure 3. Temperature profiles on the selected lines: L1, L2 and L3 in fig. 2a

The temperature variation along the selected vertical and horizontal cross-lines L1-L3 are presented in the fig. 3. These histograms provide the percentage of registered temperatures in the analyzed picture and enable the verification of the thermal status of the SWB building. It can be easily noticed that the largest temperature variation goes along the horizontal line L1 (over seven centigrade) and shows the vast heat losses at the balcony frame and windows.

The improperly mounted insulation of the balcony window on wall surface leads to increasing heat flow through the wall – line L2. Relatively high heat losses occur in the case of the roof. Insufficient insulation thickness of the ceiling becomes detectable as the temperature increases up to $-10,3\text{ }^{\circ}\text{C}$ – it is about 3K temperature difference in relation to ambient air.

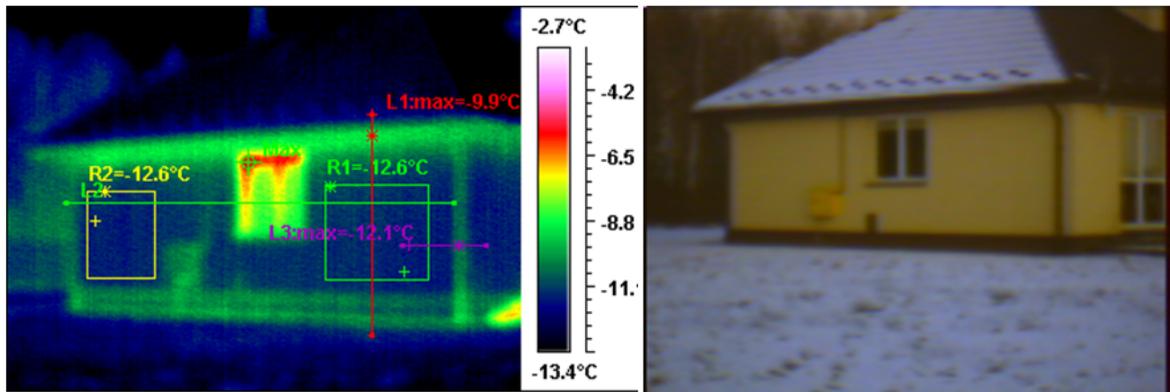
Figure 4. Thermal and natural images of sideways of *ROBERT* building

On another picture of *ROBERT* building – the sideways wall – the heat losses reach the high value because of too low heat transfer coefficient for the window – fig. 4.

The temperature difference in R1 amounts to 1,2K, but in the area R2 the smaller difference of 0,8K is observed, which means that on that part of the wall the insulation was put carefully and with the same thickness.

It is a steel construction building, what can be observed on infrared images as a linear thermal bridges. The U coefficient for the external walls has a proper value according to technical project.

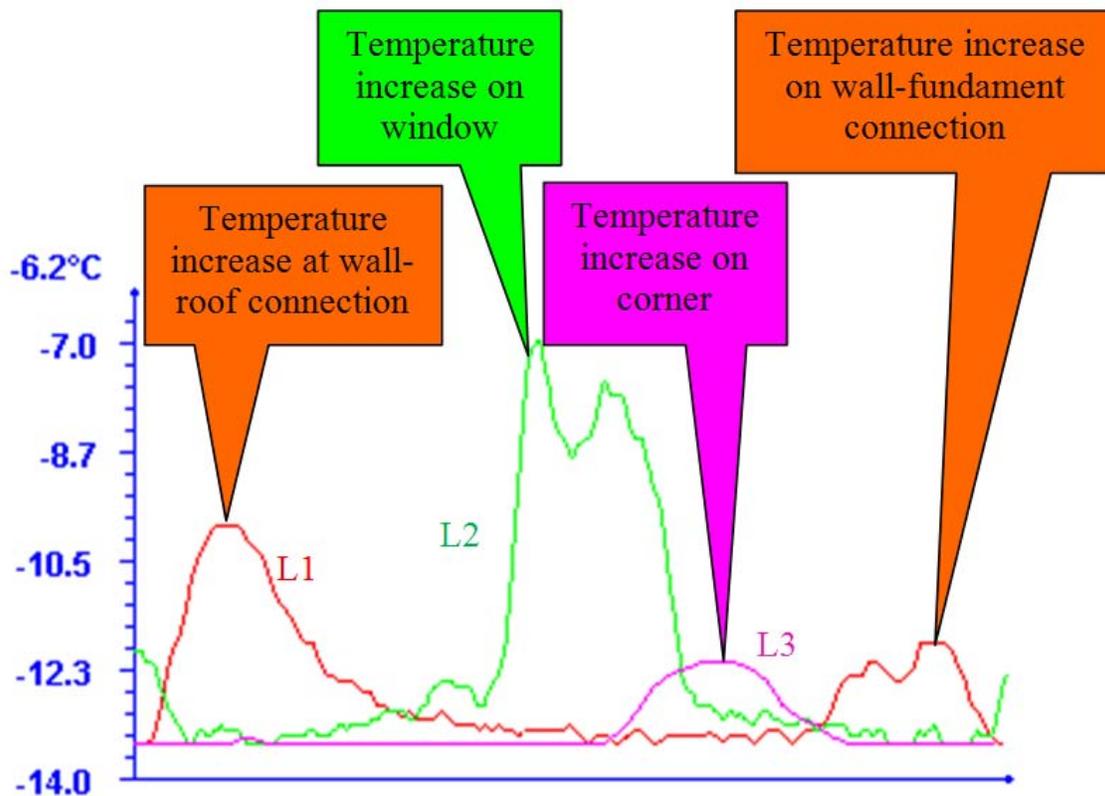
Figure 7. Temperature distribution along line L1, L2 and L3 in fig. 4

The building skeleton is visible on the thermal images. Otherwise, the insulation of the main steel figures is not done well or is less than necessary. The temperature of the middle part of the wall is about $2.5\text{ }^{\circ}\text{C}$ below the temperature on vertical corners of building – what show L1 and L3 line in fig. 7.

On the same wall the vertical temperature distribution was also analyzed (line L1). On the top of the building there is a linear thermal bridge along connection of the wall and the roof. A similar situation occurs on the connection of the bottom part of the wall connected with the fundamental wall.

In the top part of the wall the temperature is higher of about $3.0\text{ }^{\circ}\text{C}$ than the temperature on the middle part of the same wall. It is the result of defects in building insulation. The maximum temperature on Line L1 in fig. 4 is caused by the leakage of connection.

In the bottom part of the building at a connection of the external wall and the fundament there are thermal bridges with temperature close to vertical steel figures located on the corner of the building. The areas of increasing temperature occurred in the bottom of wall what may result in

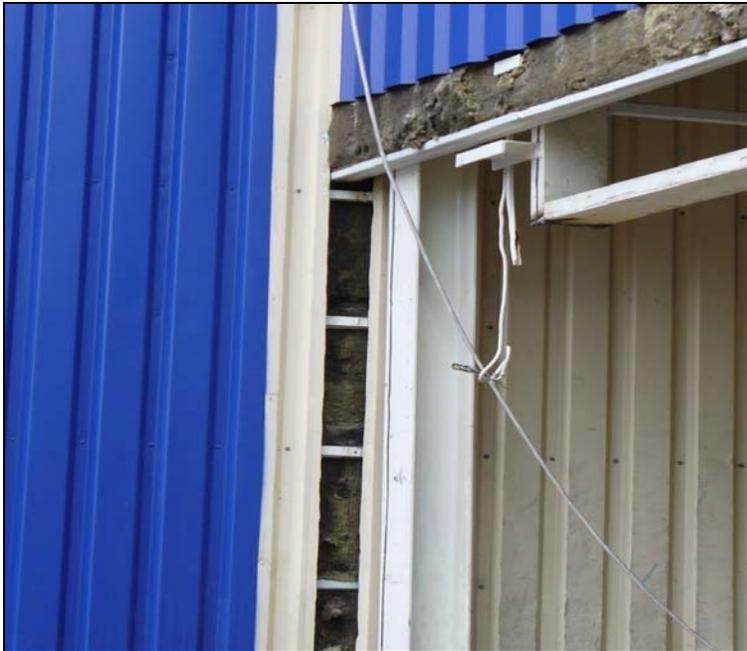
Figure 8. Typical view of the external wall in Lublin

On figure above, a vast loss of fiber glass insulation in the top part of the external wall at the entrance of the building can be seen. It leads to increasing heat losses up to level as at the wall without thermal insulation.

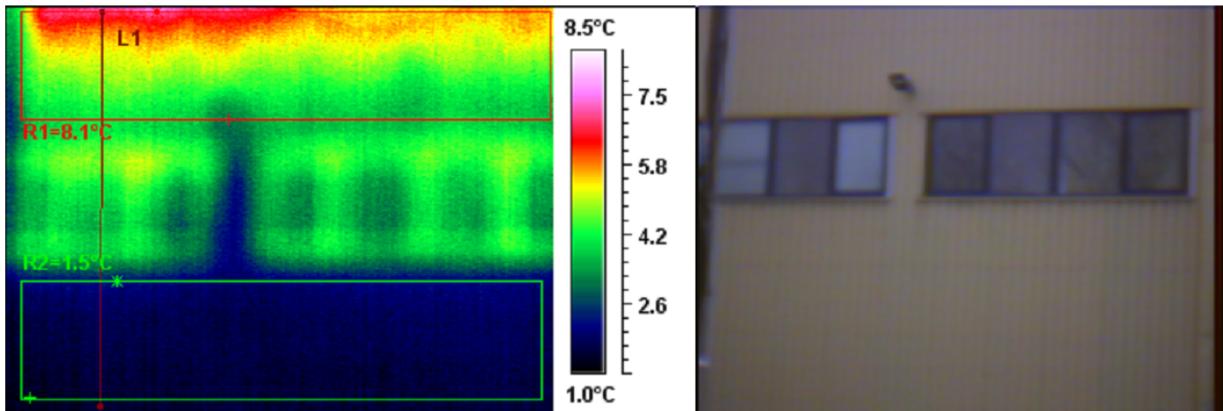
Figure 9. Infrared and normal image of the wall

The image in fig. 9 proves that the insulation in the top part of wall slid down and created the area close to roof with significant loss of thermal properties which directly results in the increase of heat consumption of the building.

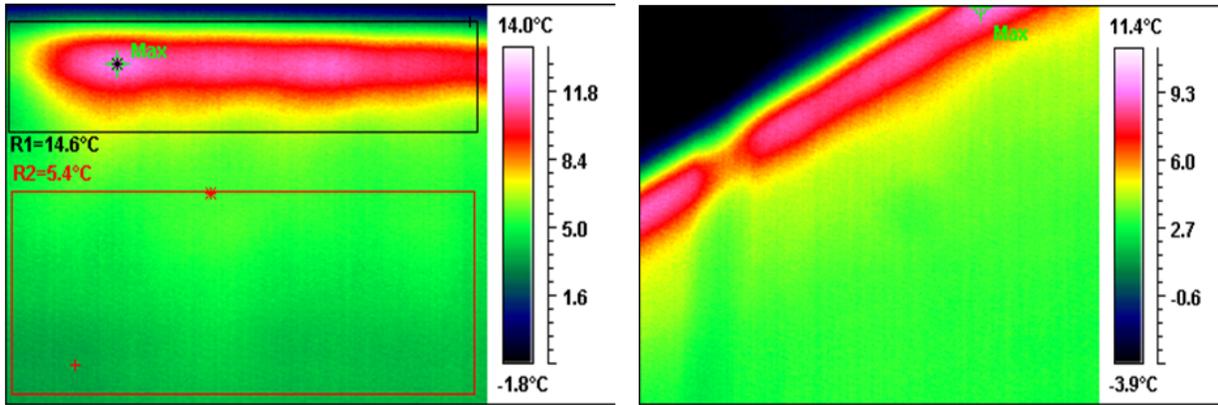
Figure 12. Infrared image of external walls surface of hypermarket

Relatively high temperatures on surface of the wall (fig. 12) $T_{\max} = +14.6 \text{ }^{\circ}\text{C}$ (at ambient temperature $-1.8 \text{ }^{\circ}\text{C}$) reflect the technological defects of the wall.

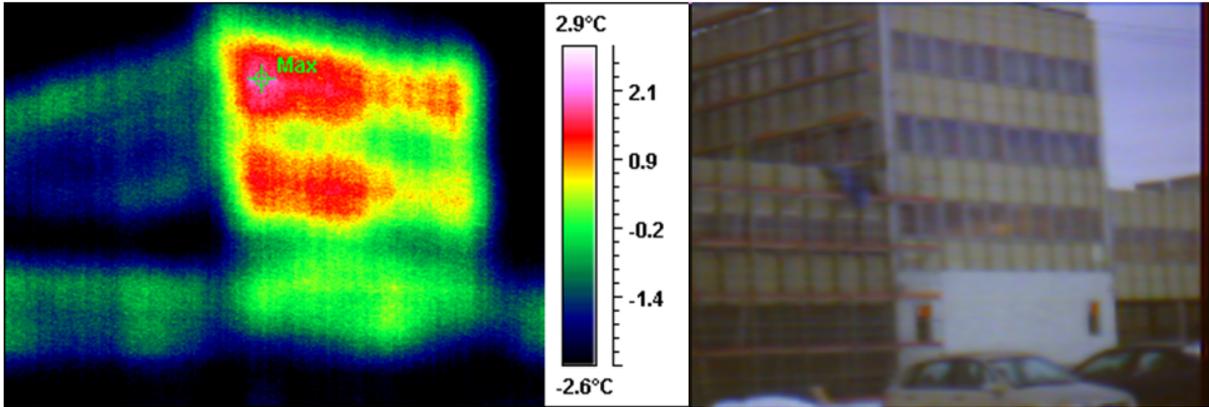
Figure 15. IR image and photography of tested walls of the "L" buildings

It can be noticed from the Figure 15a, that there is a vast area of the heat losses on the top part of the “L” building facade and in a bottom part (it is partially insulated – see, the white color area) these losses are much lower. The maximum temperature on the wall (directly indicated in the Fig. 15a) amounts 3 °C.

The infrared image – fig. 15a shows an external wall of L building before the thermal renovation. As one can see the insulation between external and internal wall layers was pulled down and, as the result, the temperature is relatively high on IR image, close to internal one.

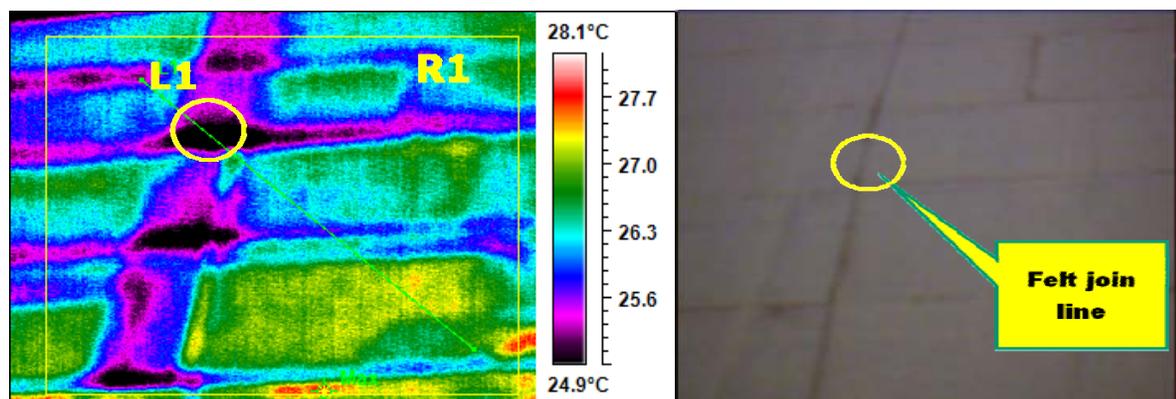
Figure 17. Roof fragment under production hall – building A

Considering the IR images taken outside the building, the areas of an improperly insulated roof has appeared – fig. 17.

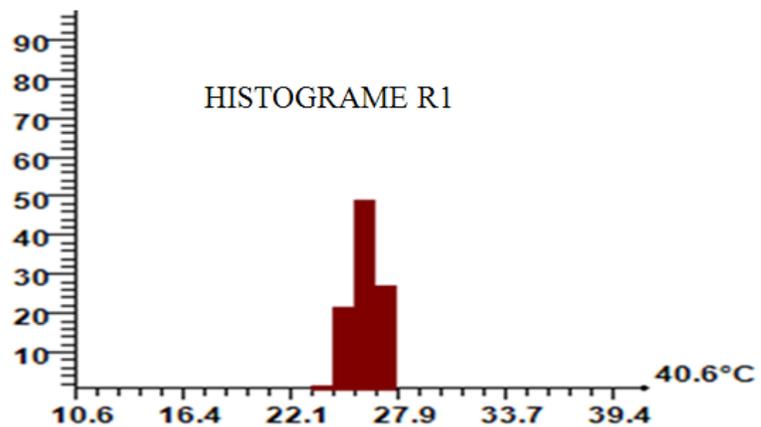
Figure 19. Histogram of R1 area in fig. 17

On the histogram – fig. 19, the temperature distribution of analyzed area R1 is presented. It reveals highly non homogenous structure of roof. The average temperature of this area amounts 26,1 °C, at external temperature of 9.0 °C taken during measurements. Summarizing, the roof insulation is insufficient which results in a vast heat losses through the boundary.

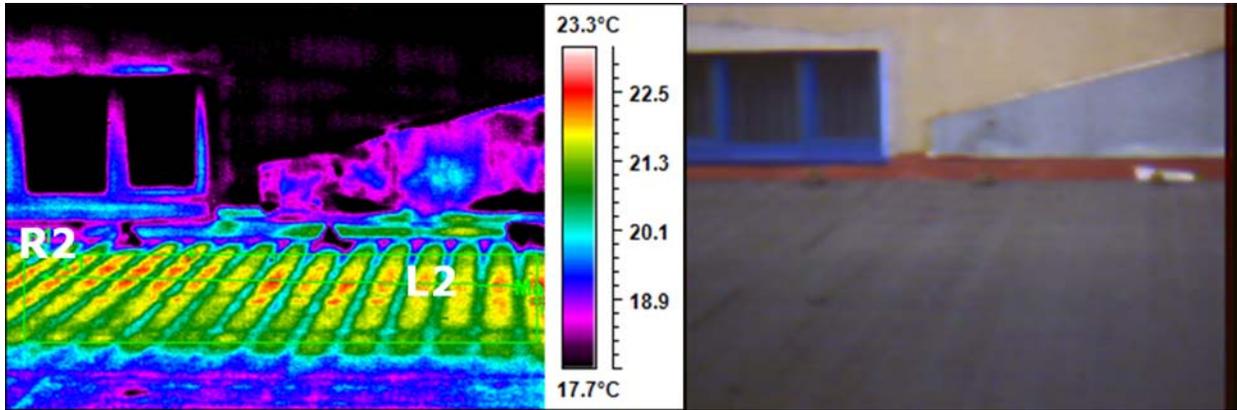
Figure 20. Roof fragment under production hall – building B

In the next figures the roof fragment of another building of the same construction as roof presented on slide 17 has been shown, but in this case with poorer insulation – building B in fig. 16. This fragment reveals that the roof is covered with the folded steel without new insulation layer. The R1 area and L1 line was selected to analysis.

Even without temperature analyzing the strong and clear image of the hot area on roof surface can be seen. It means that the heat losses of hall under analyzed roof lead to the increase of power heating consumption. The insulation layer in this case seems to be necessary.

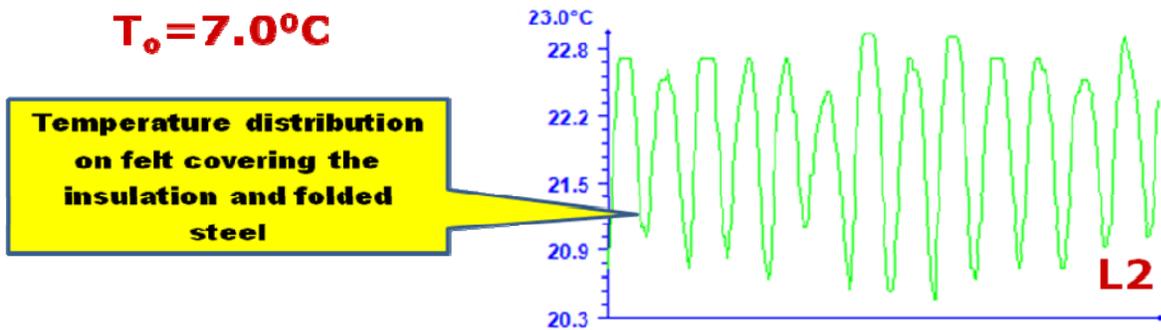
Figure 21. Temperature distribution along L2 line marked in fig. 20

The temperature distribution on the felt surface is showed by line L2 in fig. 21. Under the felt there is an old insulation layer and folded steel (folded steel is covered by polystyrene on single side).

Considering the temperature distribution, one can draw at least 2 conclusions. The insulation layer is very thin or unsuitable. The average temperature of analyzed area R2 is very high - 21,5 °C, with the external temperature during measurements amounting 7.0 °C.

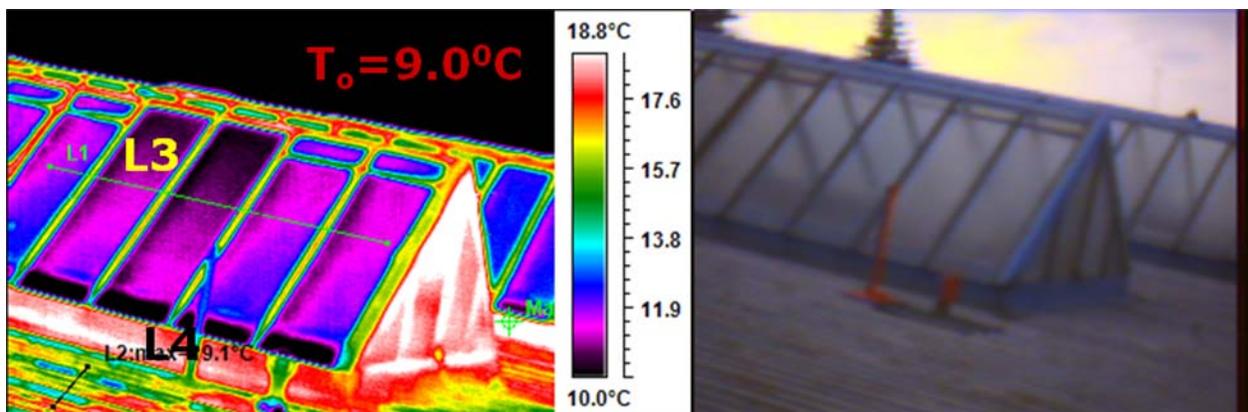
Figure 22 Roof fragment under production hall – building B

In fig. 22 the roof fragment in the same technology as previous one is presented. However there is one difference: folded steel determines the external layer. On the top of the roof there are skylights made from glass and steel. The temperature distribution was analyzed on line L3 and it leads along windows mounted in skylights. The line L4 leads along part of the roof covered by folded steel.

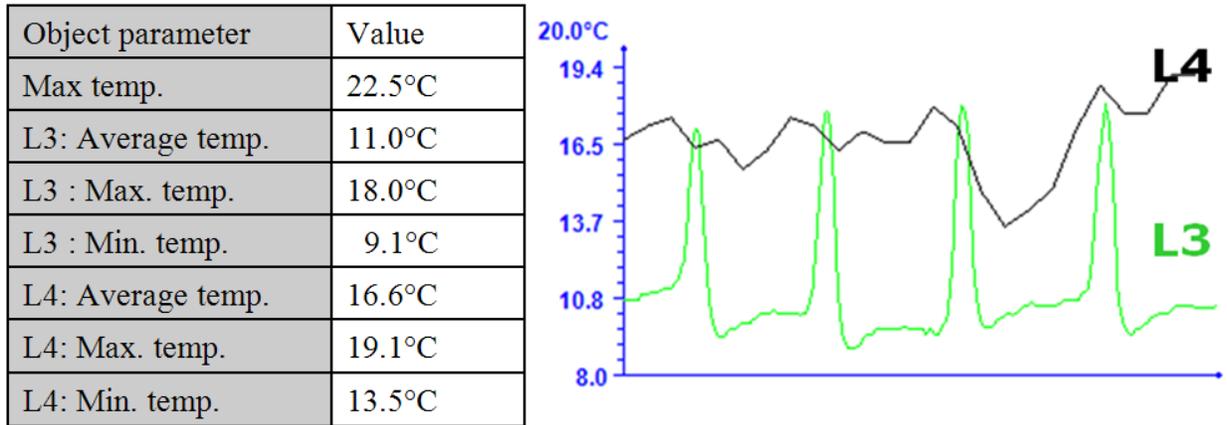
Figure 23. Temperature distribution along line L3 and L4 marked in fig. 22

The windows on the skylights have better U factor than the roof itself, even considering the insulation. These cases are presented on diagrams as line L3 and L4, respectively. It should be mentioned that figure 23 needs to be analyzed more carefully. The real temperature transformation shown by IR camera is achieved by emissivity factor directly corresponding to the material. In the case of the significant difference in emissivity between glass and steel, the two separate IR pictures have been taken at proper emissivity setting for glass and steel. The figure 23 should be considered as a first estimation of the temperature distribution and heat losses through the roof.

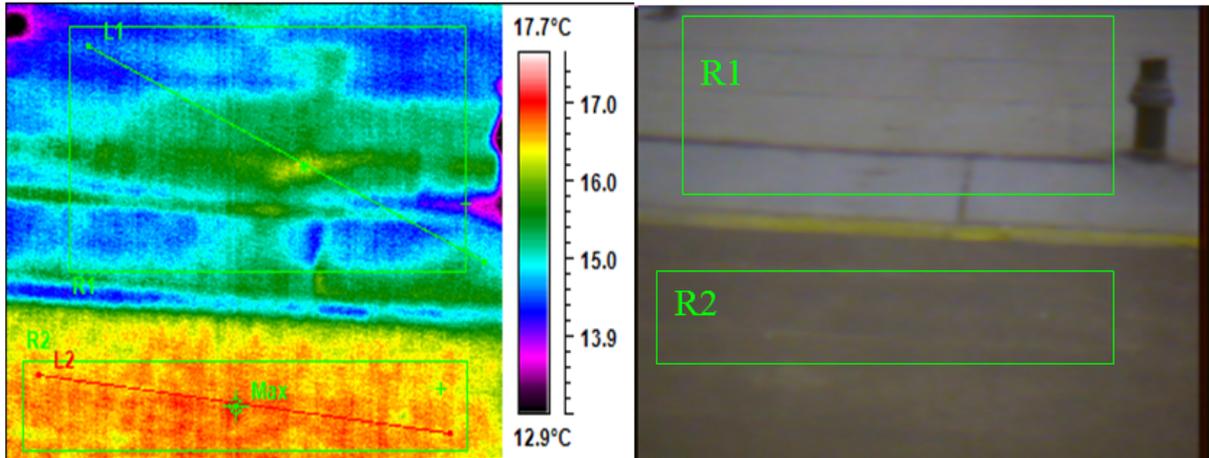
Figure 24. Roof fragment under production hall – building B

In fig. 24 a roof of the production aircraft hall as a R1 area is presented. The significant heat losses through the surface of the roof can be noticed. The average surface roof temperature amounts +17.3°C at ambient temperature +10.3°C.

The second part of the roof marked as R2 area is much better insulated. The average surface temperature amounts +15.3°C at the same ambient temperature that is presented on temperature profile along line L1 and L2 in fig. 25.

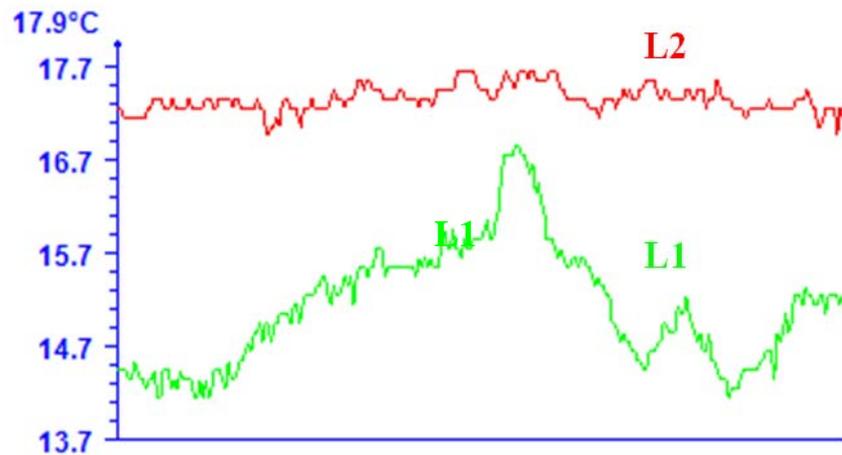
Figure 25. Temperature distribution along line L1 and L2 marked in fig. 24

The roof insulation leads to decreasing heat flow through the surface analyzed, but there is a non homogeneous structure in insulation showed on the temperature profile along Line L1 in fig. 25. The average temperature difference on roof surface was decreased by 2°C in the same weather conditions.

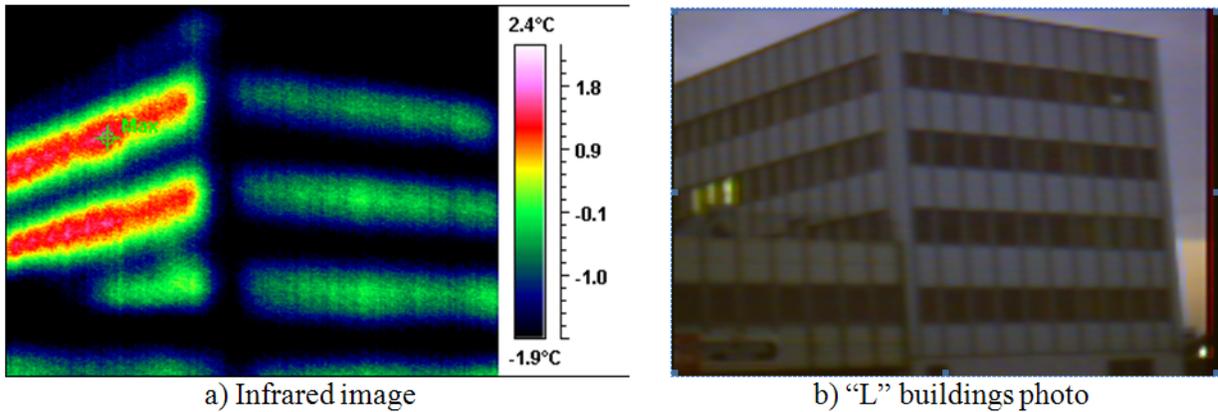
Figure 28. IR image and photo of the “L” buildings walls (after renovation)

The final effect obtained after the renovation of the external walls and replacement of the old windows is presented in the Figures 28 a, b. Comparing this pictures to the data in the Figure 27, one can see the real improvement of building thermal performance and more uniform distribution of the temperatures on the same right side facade.

It should be noticed that the left side of the imaged IR picture, Fig.28a, shows still a very large heat losses through the walls. This part is still improperly insulated and it will be renovated till the end of 2008.

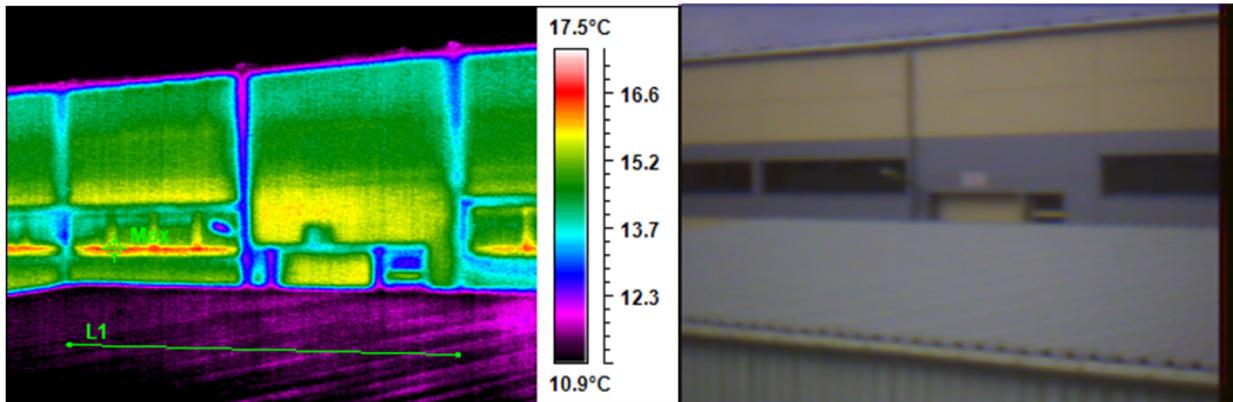
Figure 30. IR image and photo of the production hall walls (after renovation)

In the fig. 30 there was presented the roof of an aircraft production hall after the thermo modernization – building B. The proper result obtained is a result of proper insulation thickness selection as well as it took part in building's art of state. At the average ambient temperature $+10^{\circ}\text{C}$, the temperature on the roof surface is in the range between $+9,7$ to $+10,4$ on 97.5% roof surface – fig. 31.

The maximum temperature is still a proof of an improperly mounted insulation. In the area close to the bottom part of the window the temperature reaches its maximum $+17.5^{\circ}\text{C}$ and it means that the modernization was done carelessly.

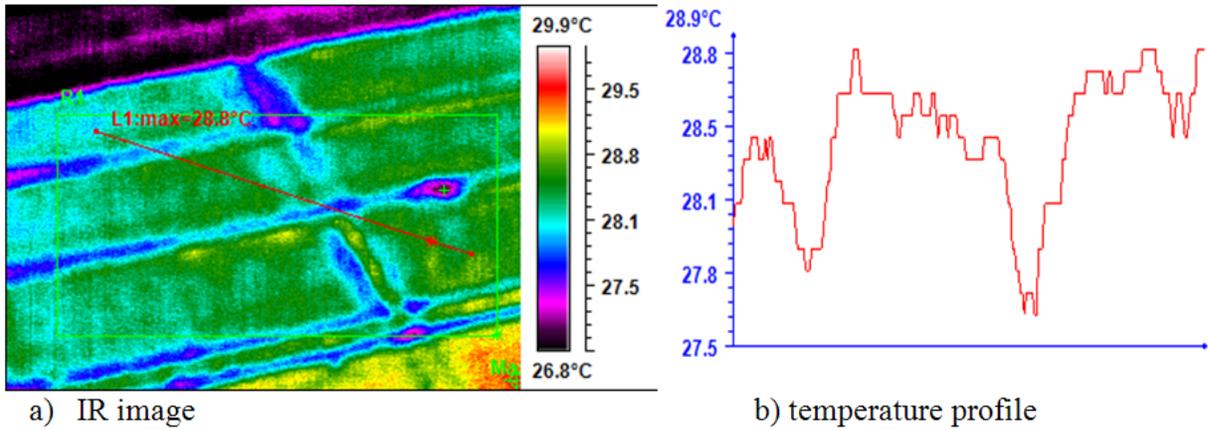
Figure 32. IR image and photo of the production hall roof (after renovation)

A similar effect of thermo renovation can be seen in fig. 32. A part of the roof after the additional insulation and a new layer of felt put on does not give results expected. There are visible temperature differences along roof surface because of the various thickness of the insulation.

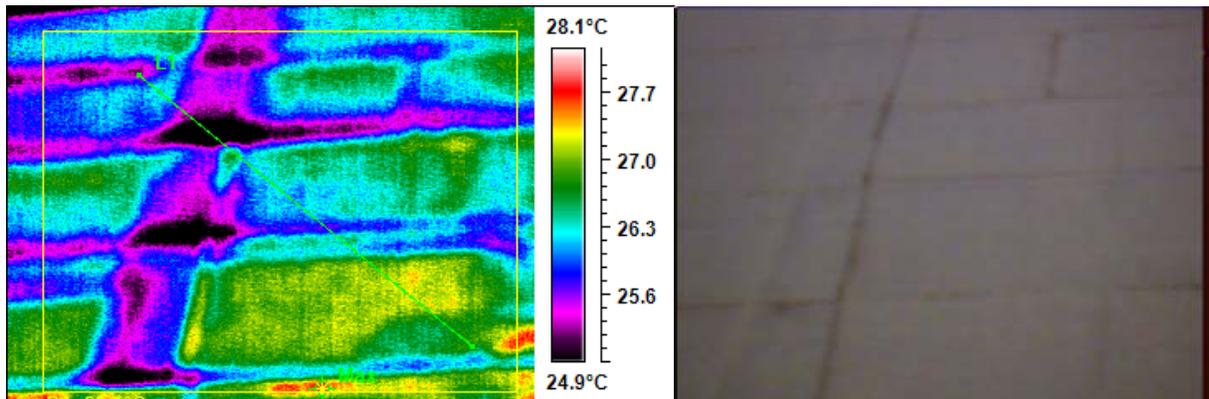
Figure 33. IR image and photo of the production hall roof (in the case of cooling system inside the building – after renovation)

The non homogeneous temperature distribution on the surface of the roof reflects improperly selected insulation thickness. There is a working air-conditioned system inside the hall and cool air is accumulated under the ceiling what leads to uncontrolled cool losses. The air inside the building in that case should be mixed to prevent temperature stratification and decrease temperature difference between ambient air and cooling room.
