## Case Study 2: Air Pressurisation Tests

ROBUST Project: WP 2.4

Author(s):  
Israel Adetunji

This report documents the outcome of air pressurisation and smoke propagation tests of two industrial sheds carried out on the 12 November 2008 in Milton Keynes, UK. Both buildings are typical 1960s and 70s steel framed industrial sheds with block wall partitions. The buildings are clad with asbestos sheets and cavity brick forming the dwarf wall. The first building (Unit 2 – 4) was tested “Before renovation” while the second (Unit 16) was tested “After renovation”. The renovated building was overcladded with mineral wool insulation and steel sheet to achieve the UK current thermal requirement (roof 0.25 and wall 0.35 W/m<sup>2</sup>K).

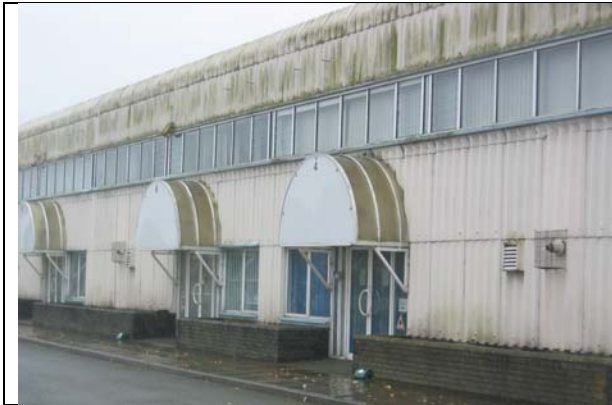
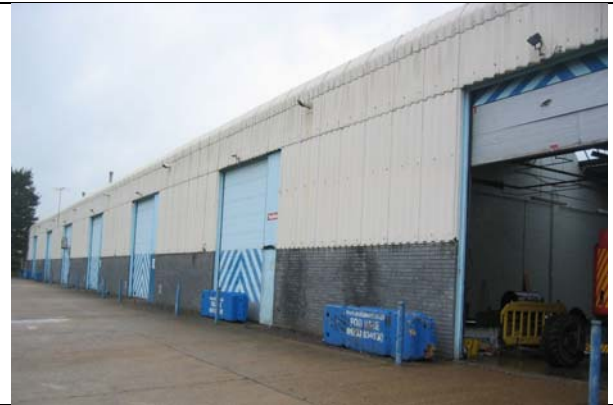
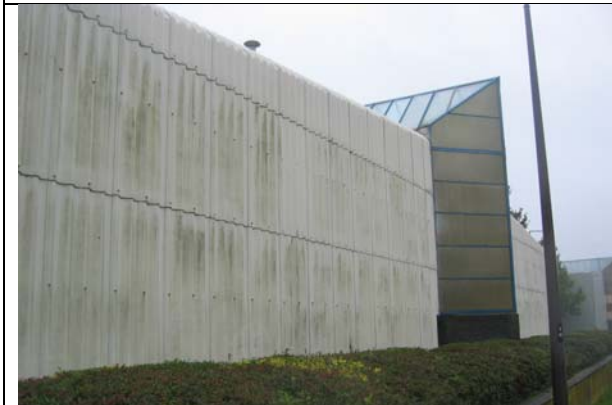
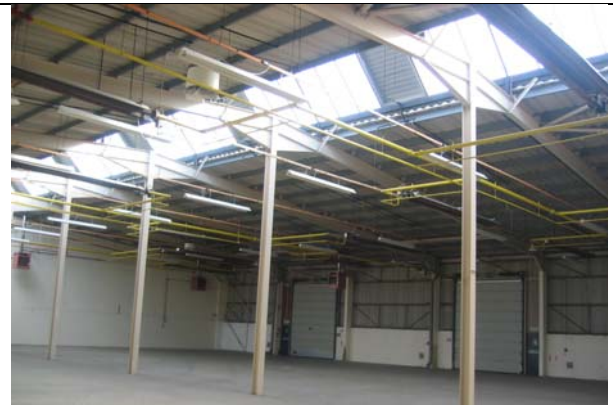
**Figure 2: Pictures showing Units 2 - 4**

The buildings tested are typical 1960's and 1970s large steel portal frame industrial shed, which are partition with block walls into small units (double and single units). Unit 2 – 4 is a double unit and was tested “Before Renovation, while Unit 16 is a single unit and was tested “After Renovation”.

The buildings are constructed around a steel frame which is cladded with dwarf wall and asbestos cement sheet. The dwarf wall is an uninsulated cavity brick wall. On top of the dwarf wall is a single skin asbestos cement sheet. The roof consists of a single asbestos cement sheet and a single glazed roof light, which runs along the centre of the roof and down on the north elevation. On the west side of the building are a series of a single glazed windows. The floor is made of a ground bearing concrete slab.

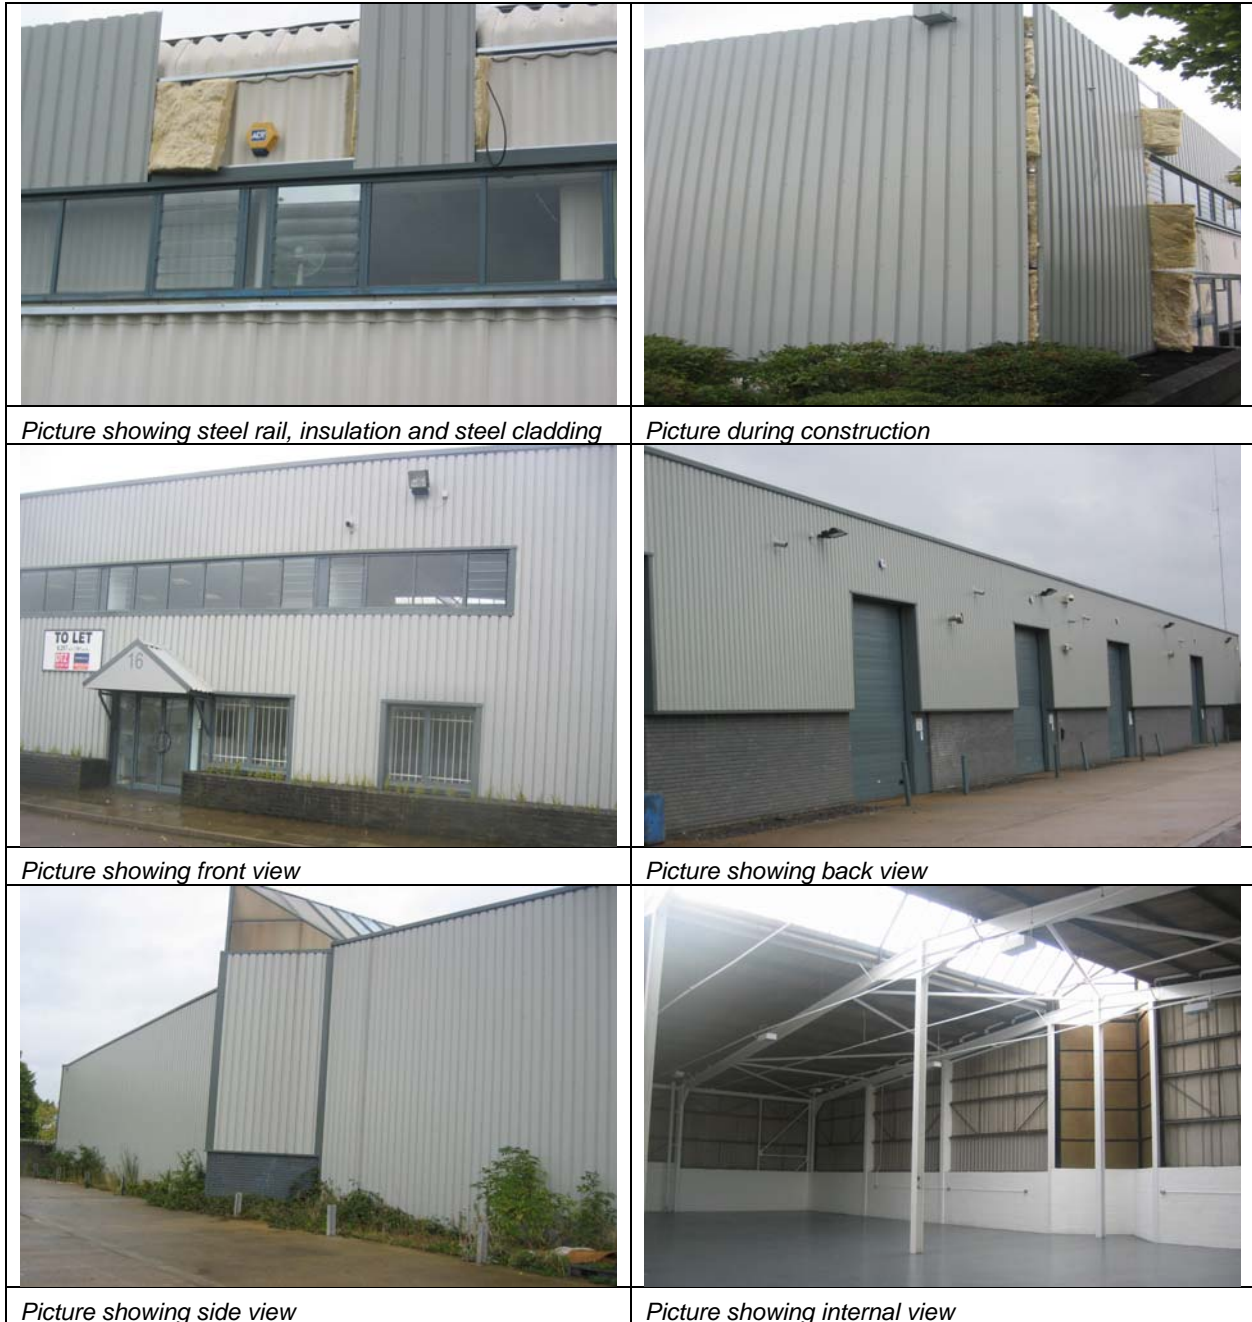
**Figure 3: Pictures showing unit 16**

This is a single unit with a total floor area of about 630 m<sup>2</sup>. The is effectively the same construction as unit 2-4 except that it is half the size and the existing asbestos sheet cladding has been over-cladded with mineral wool insulation and steel external liner attached to the existing envelope via steel brackets as shown in the picture below. Insulation thickness of 180mm and 120 mm for roof and walls were used to comply with the current minimum UK regulatory thermal requirement (for roof 0.25 and wall 0.35 W/m<sup>2</sup>.K). The dwarf cavity walls remain uninsulated. All doors, windows, floor and internal walls were repainted.

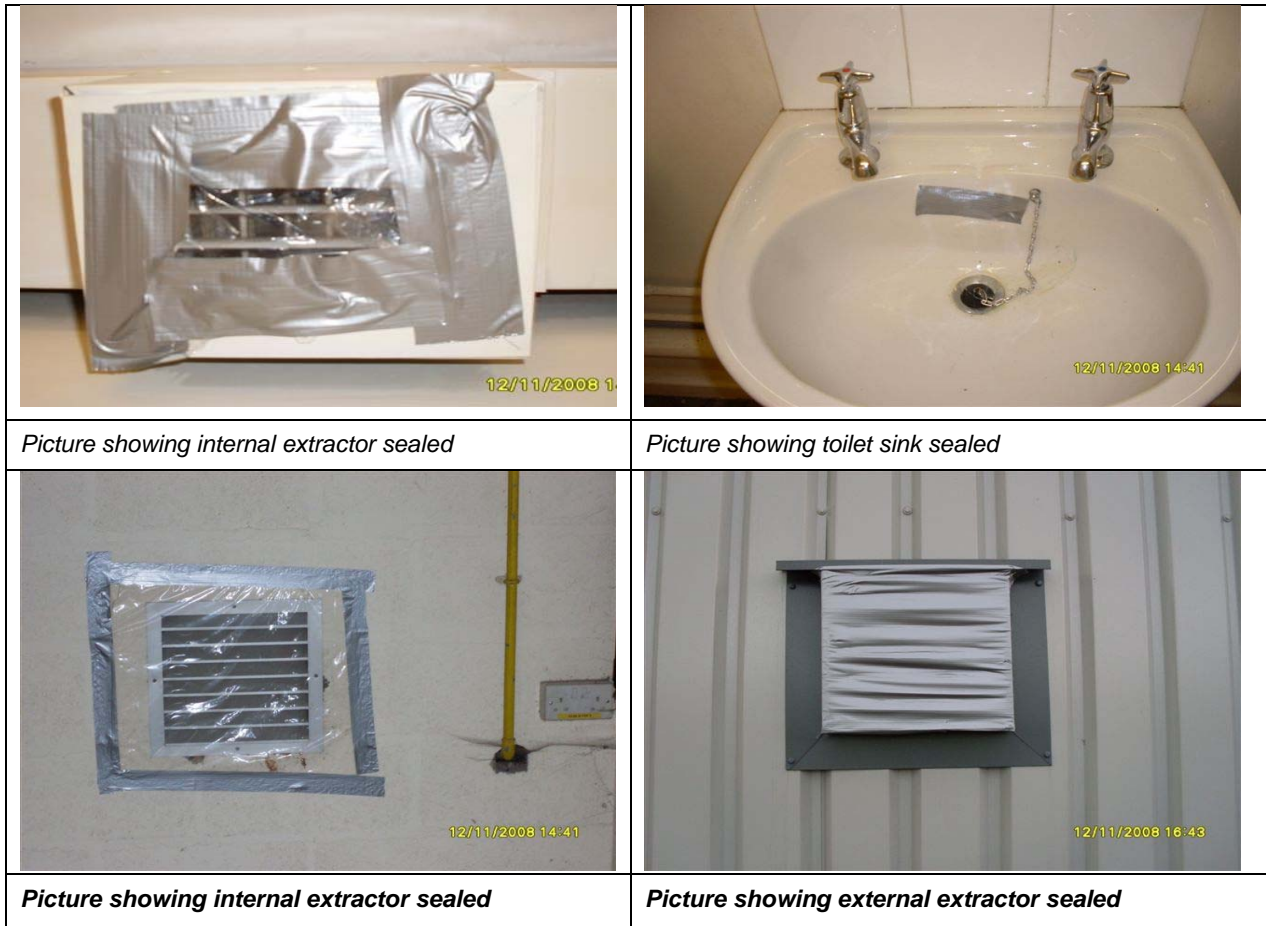
**Figure 4: Picture showing temporary sealing for the test**

The site preparation complied with BS EN 13829:2001 Method B – Test of the Building Envelope. All drainage traps were filled with water. All external doors, windows, trickle vents, smoke vents and all passive ventilation systems were closed. All mechanical ventilations were temporary sealed to prevent air leakage through the system during the tests.

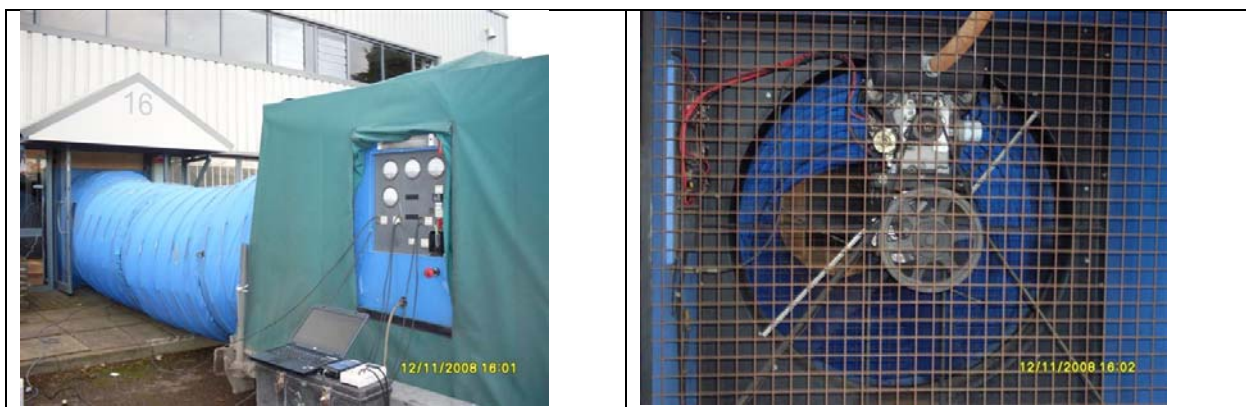
Figure 5: Pictures showing fans installation for the test

The fan system used on this test was a high capacity petrol-driven trailer fans sealed into the main entrance doors on the front elevation as shown in the pictures below. This fan is calibrated to BS848 with a volume flow rate between 2.5 – 33.0  $\text{m}^3/\text{s}$ .

The size of the fan was established in accordance with ATTMA TS1 requirement, which states that the fan must be capable of achieving at least 80% of the required air volume flow rate, at 50 Pascal pressure difference ( $Q_{50}$ ).  $Q_{50} = A * 10 * 0.8 / 3600$  ( $\text{m}^3/\text{s}$ ) where 10 is the Air Permeability target, and  $A$  = area of walls, roof and ground floor.

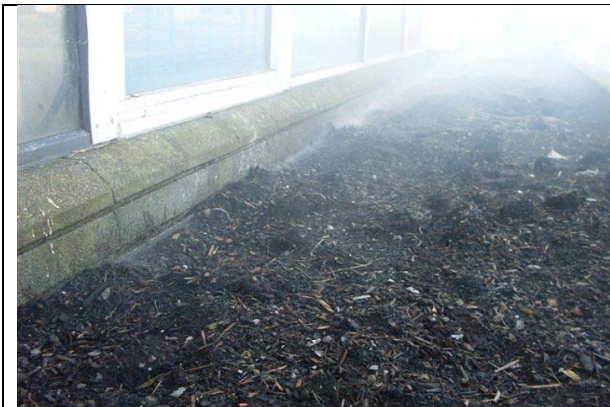
The test revealed air leakage through the building envelope from all possible interfaces as listed below:

**Figure 6: Picture showing leakage from window sill**

Based on the finding, it is therefore, strongly recommended that a separate airtightness membrane be introduced directly on the external surface of the existing cladding before insulation and new over cladding are installed. This airtightness membrane needs to be breathable membrane (vapour permeable layer) to allow moisture movement through the envelope and avoid condensation risk, and at the same time prevent air leakage in line with current building regulation.

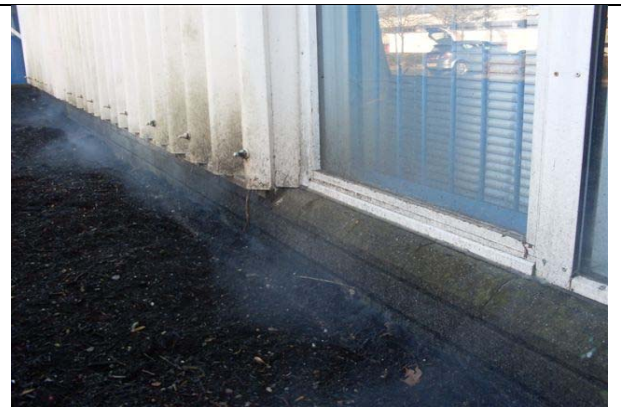
**Figure 7: Picture showing leakage from asbestos cladding and dwarf wall interface**

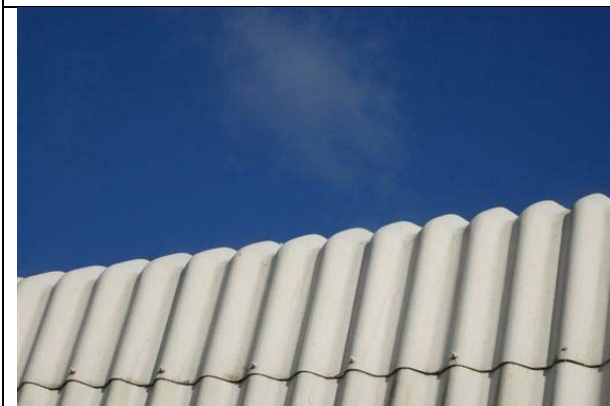
**Figure 8: Picture showing leakage from the eaves interface**

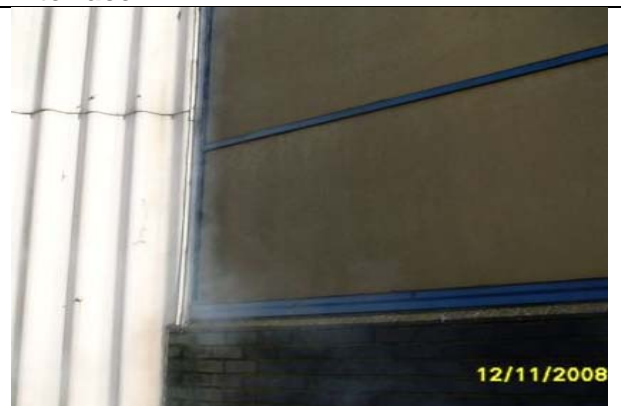
**Figure 9: Picture showing leakage from window jamb**

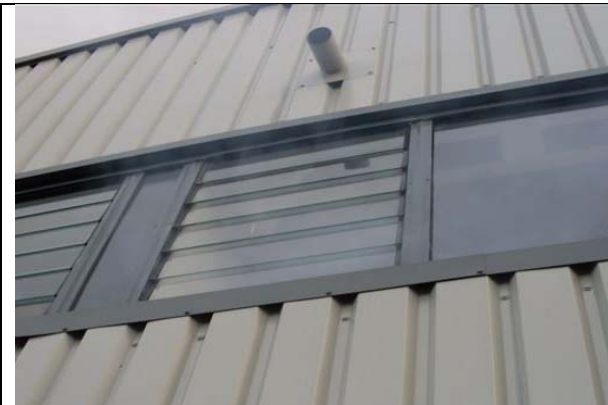
The following leakage paths were identified through the building envelope:

**Figure 10: Picture showing leakage from window interface**

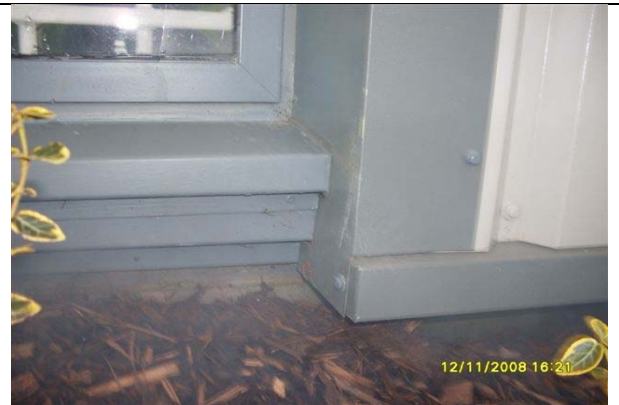
**Figure 11 Picture showing leakage from window jamb**
