ROBUST: Renovation of Buildings Using Steel Technologies

**WP 2.4 Physical test on roofs and facades before and after upgrading
to assess their performance**

Individual activity report

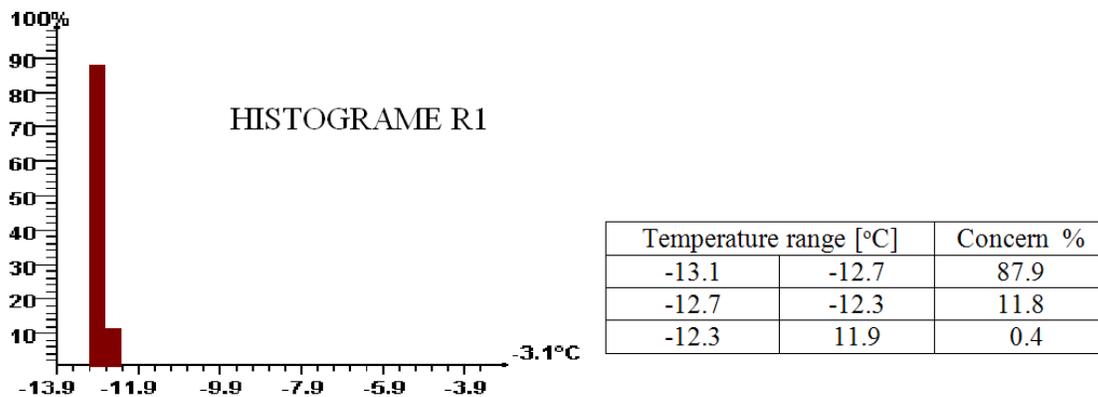
Figure 5. Percentage concern of temperature range in R1 area in fig. 4

In the selected areas of thermal image R1 and R2 the temperature distribution was analyzed. Bar chart and histograms in fig. 5 and 6 together with percentage concern of selected range of temperature are presented.

The temperature difference in R1 amounts to 1,2K, but in the area R2 the smaller difference of 0,8K is observed, which means that on that part of the wall the insulation was put carefully and with the same thickness.

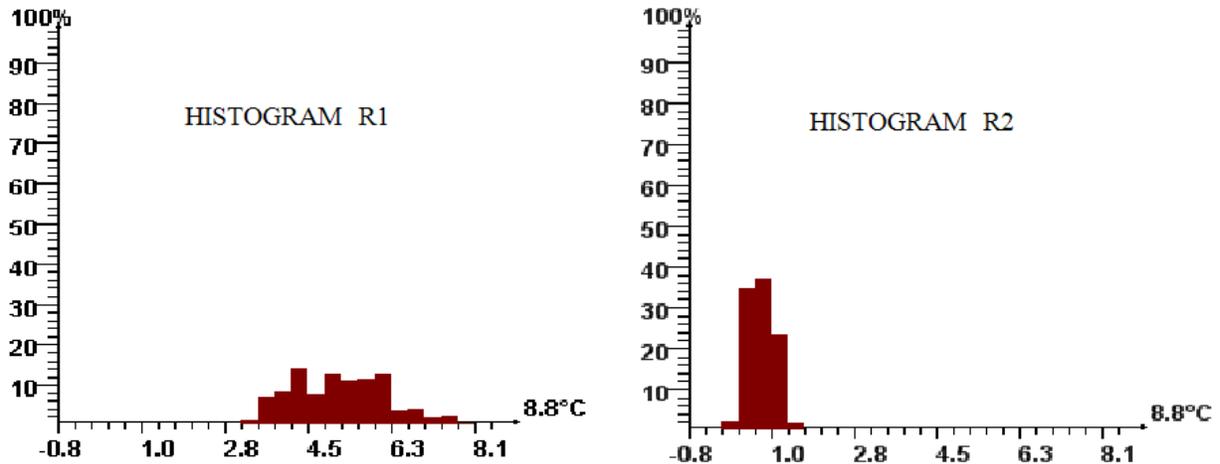
Figure 10. Temperature histogram corresponding in area R1 and R2 in Fig. 9

On the external wall of building – see fig. 9, numerous colors appear on the infrared images what reflects diverse insulation thickness inside the wall. The histograms of temperature distribution presented in fig. 10, 11 on selected parts of the wall R1 and R2 were prepared.

The image in fig. 9 proves that the insulation in the top part of wall slid down and created the area close to roof with significant loss of thermal properties which directly results in the increase of heat consumption of the building.

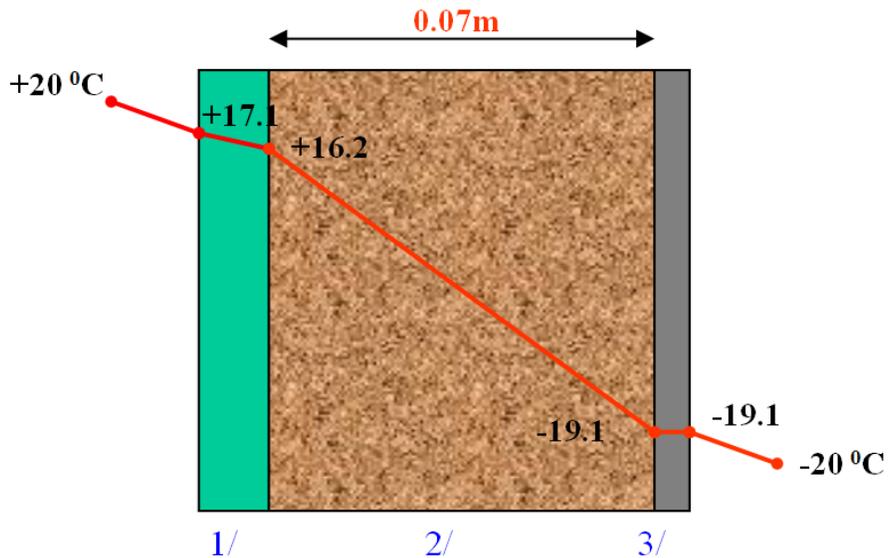
Figure 14. Temperature distribution in an external wall (building „L”)

A design heat transfer coefficient for the external walls in “L” assembly buildings was assumed to amount: $U = 0.543$ [W/m²K]. This value corresponds to the technology level close to the specific energy demands amounting ~ 200 kWh/m²·a. Relying on the very intensive “cold feeling” during the winter season it was assumed that the insulating-course of mineral wool has slid down inside the frame walls. Apart of many leakages in the large windows area it caused a significant discomfort in the rooms. These problems forced the investment activities and thermo-renovation works.

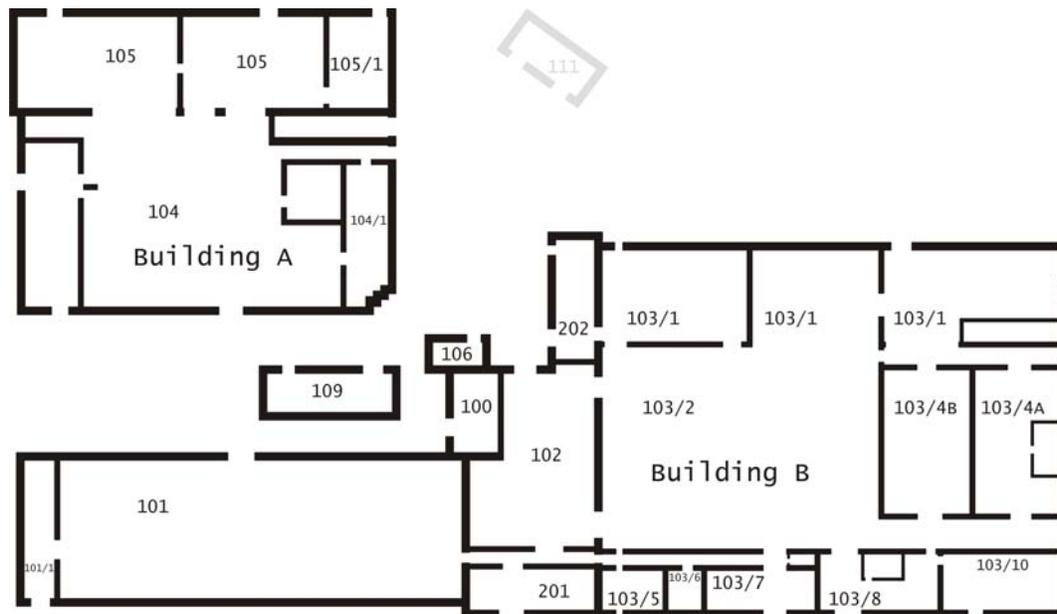
Figure 16. Cross section of aircraft production hall

In the next figures the roof fragment of another building of the same construction as roof presented on slide 17 has been shown, but in this case with poorer insulation – building B in fig. 16. This fragment reveals that the roof is covered with the folded steel without new insulation layer. The R1 area and L1 line was selected to analysis.

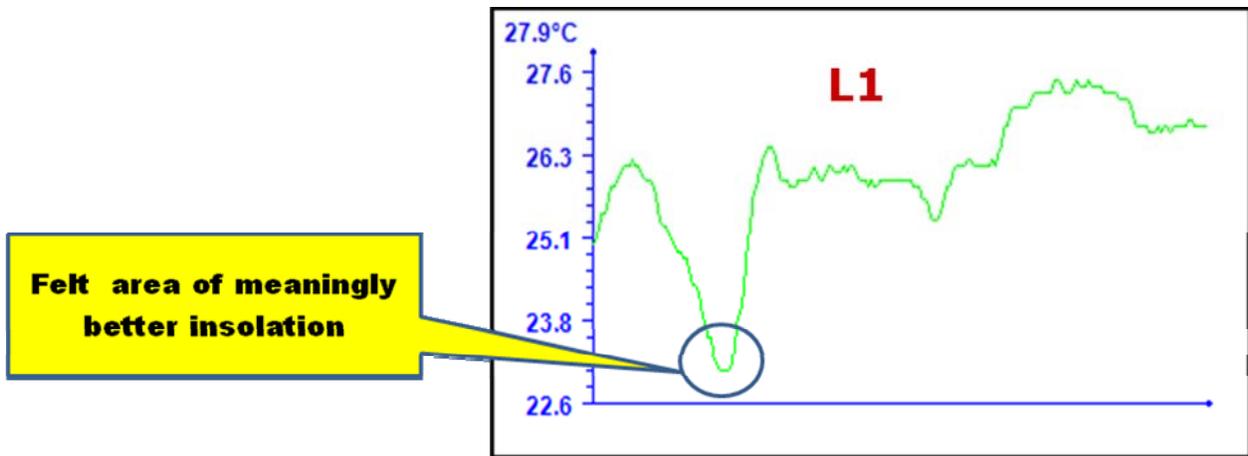
Figure 18. Temperature distribution along L1 line in fig. 17

The minimum of line L1 presented in fig 18 corresponds with the area of best insulation – see black places in fig. 17.

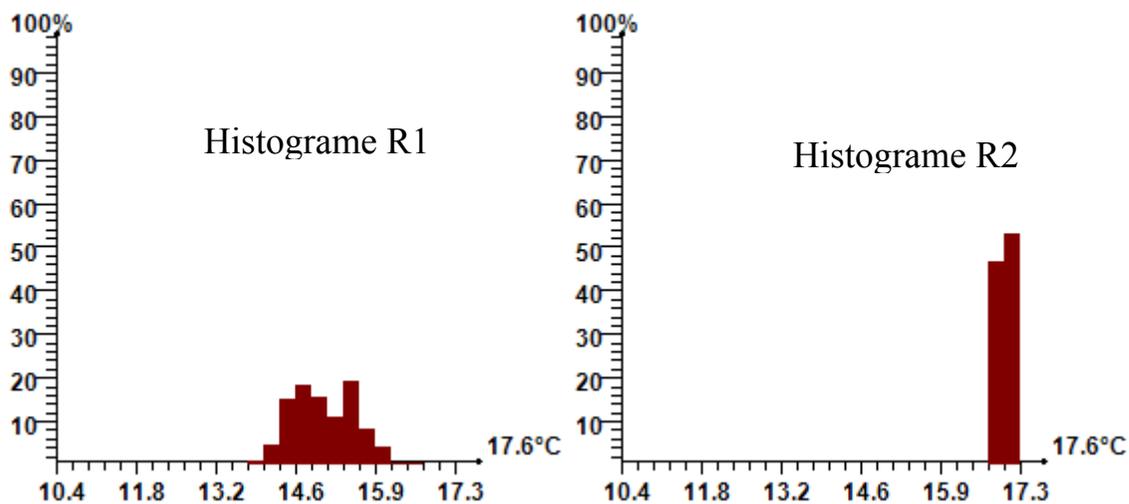
Figure 26. Percentage concern of temperature in areas R1 and R2 marked in fig. 24

In fig. 24 a roof of the production aircraft hall as a R1 area is presented. The significant heat losses through the surface of the roof can be noticed. The average surface roof temperature amounts +17.3°C at ambient temperature +10.3°C.

The second part of the roof marked as R2 area is much better insulated. The average surface temperature amounts +15.3°C at the same ambient temperature that is presented on temperature profile along line L1 and L2 in fig. 25.

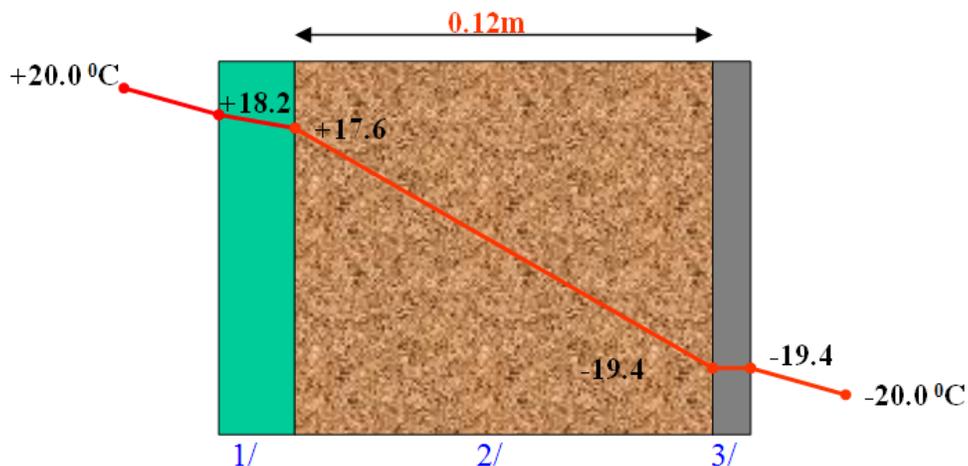
Figure 27. Temperature distribution in an external wall – after the renovation (building „L”)

During refurbishment processes it has been proved that the mineral wool was falling down inside the frame. The new insulation based on mineral wool layer of the thickness $d = 0.12$ m (previously 0.07 m) has improved thermal performance of the walls up to the value $U = 0.333$ [W/m²K]. The typical temperature distribution in the external walls after the thermo-renovation is presented in fig. 27.

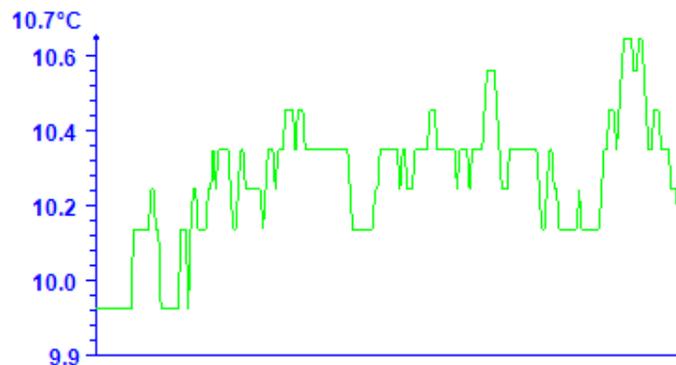
Figure 31. Temperature distribution along line L1 marked in fig. 30

In the fig. 30 there was presented the roof of an aircraft production hall after the thermo modernization – building B. The proper result obtained is a result of proper insulation thickness selection as well as it took part in building's art of state. At the average ambient temperature $+10^{\circ}\text{C}$, the temperature on the roof surface is in the range between $+9,7$ to $+10,4$ on 97.5% roof surface – fig. 31.

The maximum temperature is still a proof of an improperly mounted insulation. In the area close to the bottom part of the window the temperature reaches its maximum $+17.5^{\circ}\text{C}$ and it means that the modernization was done carelessly.

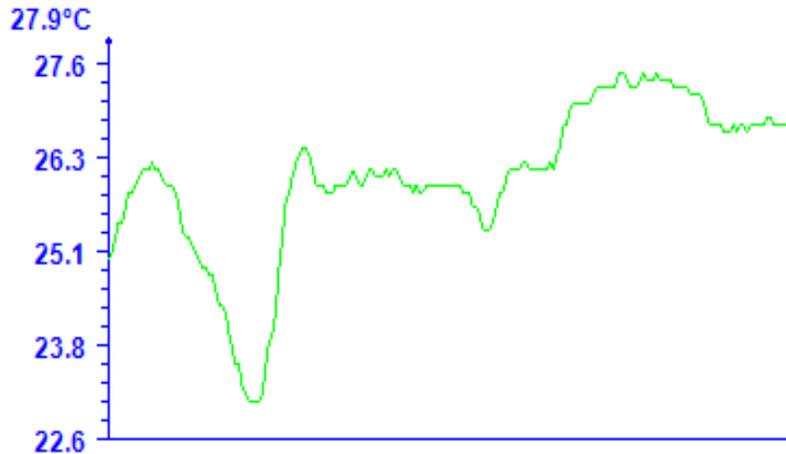
Figure 34. Temperature profile along L1 line in fig. 33

The non homogeneous temperature distribution on the surface of the roof reflects improperly selected insulation thickness. There is a working air-conditioned system inside the hall and cool air is accumulated under the ceiling what leads to uncontrolled cool losses. The air inside the building in that case should be mixed to prevent temperature stratification and decrease temperature difference between ambient air and cooling room.

In those places where the mounted insulation sticks to each other, there is sudden decrease of the temperature close to temperature in cooling room and it equals 23.0 °C at ambient temperature as 28.5 °C. Such a difference may lead to the large amount of cooling energy flow out of the building.
